**Ardmore Park Quarry**

# Annual Review

**1 January 2021 - 31 December 2021**

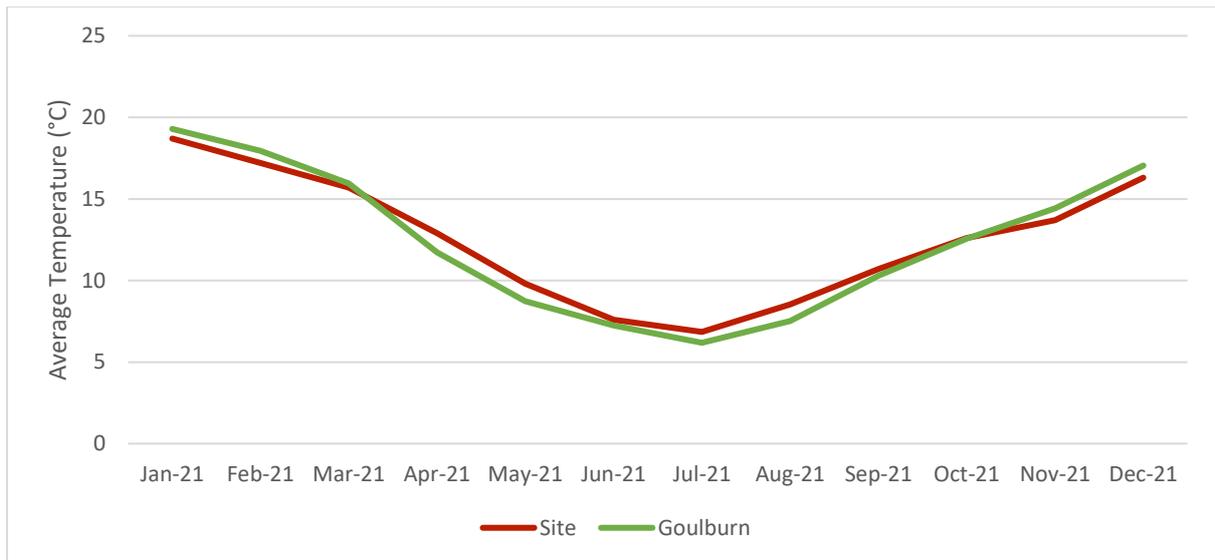
Figure 4: Average monthly temperature.

The average monthly temperatures recorded by the on-site weather station (location shown in Figure 3) ranged between 6.85°C to 18.7°C throughout the reporting period. The temperature range observed is heavily influenced by the Quarry's elevation within the Southern Tablelands Region. Average temperature is presented in Figure 4, along with the same data for the Goulburn weather station of the NSW Government's New South Wales Air Quality Monitoring Network, which is comparable.

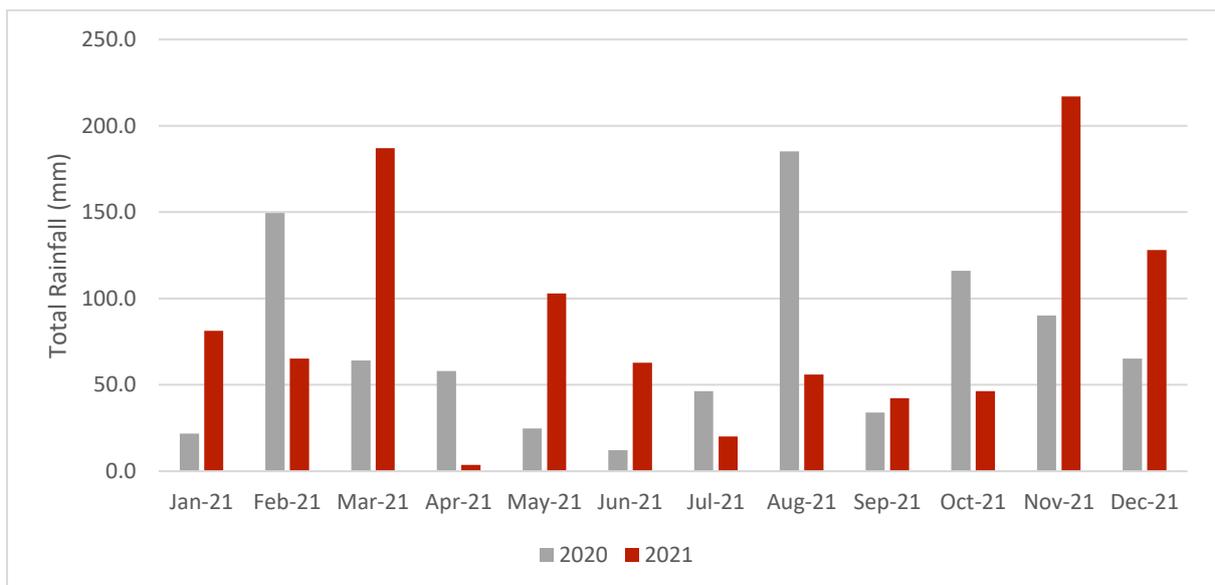
Figure 5: Total monthly rainfall recorded at on-site weather station, comparison of 2020 and 2021.

Data collected during 2021 indicated an elevated level of rainfall in comparison to 2020, with approximately 1013 mm of rain recorded compared to 867.6 mm observed in the previous year (Figure 5).

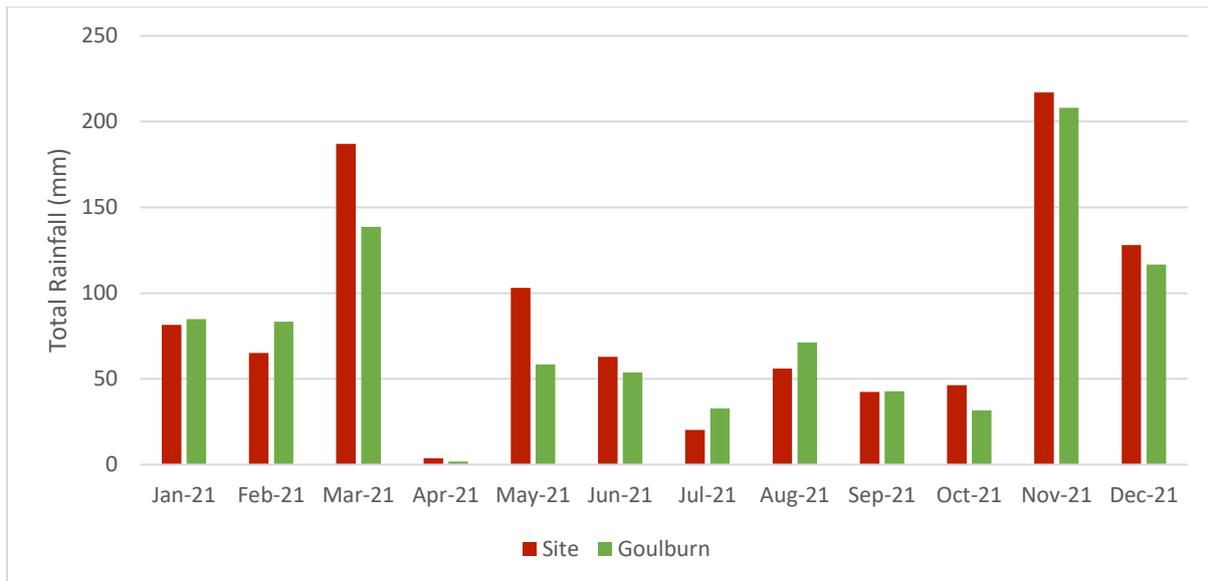
Figure 6: Total monthly rainfall in 2021, comparison of on-site weather station and Goulburn weather station.

Rainfall data collected by the on-site weather station was consistent with records from the Goulburn weather station of the NSW Government's New South Wales Air Quality Monitoring Network (Figure 6).

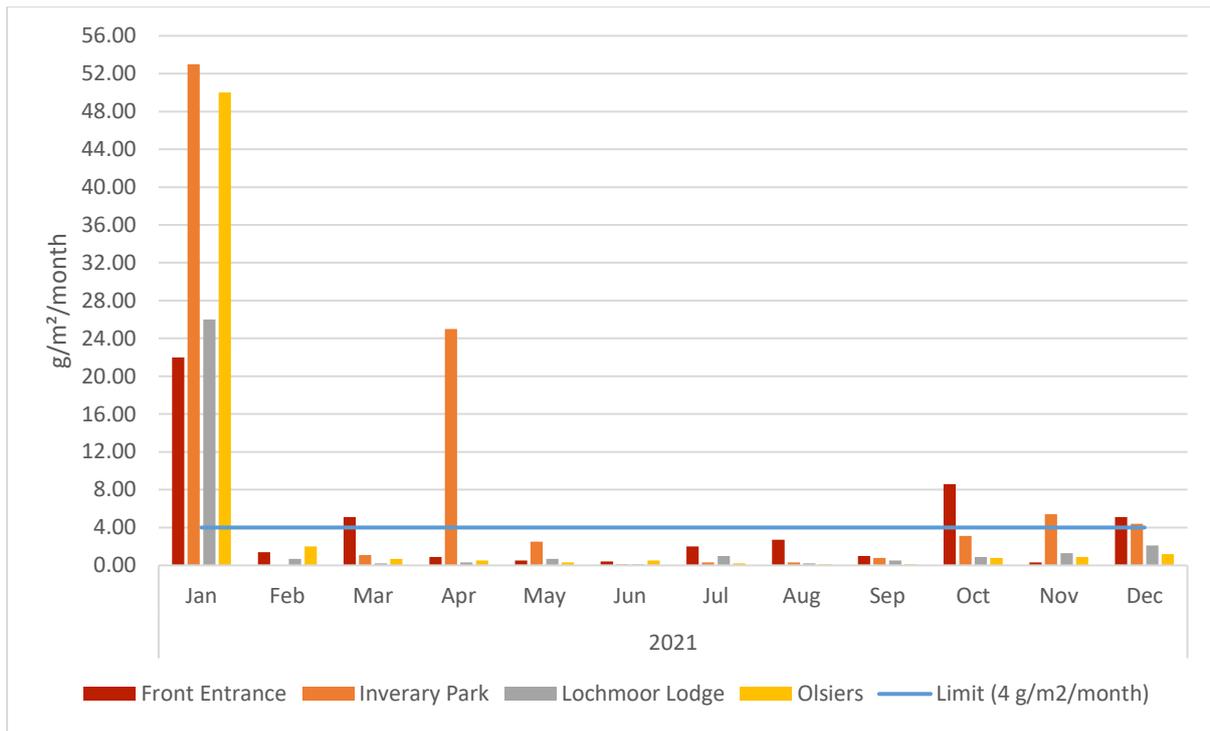
Figure 7: 2021 Deposited dust (insoluble solids) results. Limit of 4 g/m<sup>2</sup>/month for total impact of particulate matter emissions generated by the project is presented as a blue line.

Samples collected are analysed at a NATA-accredited laboratory, with the insoluble solids fraction of the total sample used to assess compliance with the air quality criteria specified in Condition 7 of Schedule 3 of the Approval (4 g/m<sup>2</sup>/month total, 2 g/m<sup>2</sup>/month incremental). Results for 2021 are presented in Figure 7.

As shown in the graph, there were a total of 10 instances where the primary results for insoluble solids were greater than the total limit, across six months (January, March, April, October, November, and December).

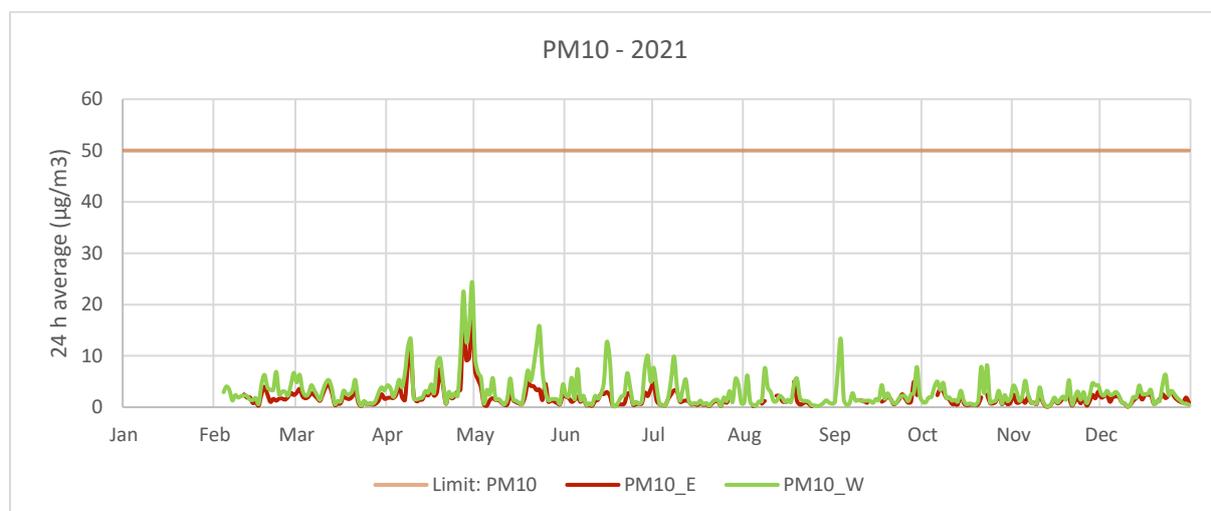
Figure 8: 2021 PM<sub>10</sub> data for both units, 24-hour averaging, with Project Approval limit.

The data for 2021 as a 24 hour average is presented in Figure 8 and Figure 9 for PM<sub>10</sub> and PM<sub>2.5</sub>, respectively, with the Project Approval limits included on the graphs. As shown, while particulate matter levels recorded by both units increased in April 2021, they were otherwise relatively stable, and remained below their respective limits at all times throughout the year.

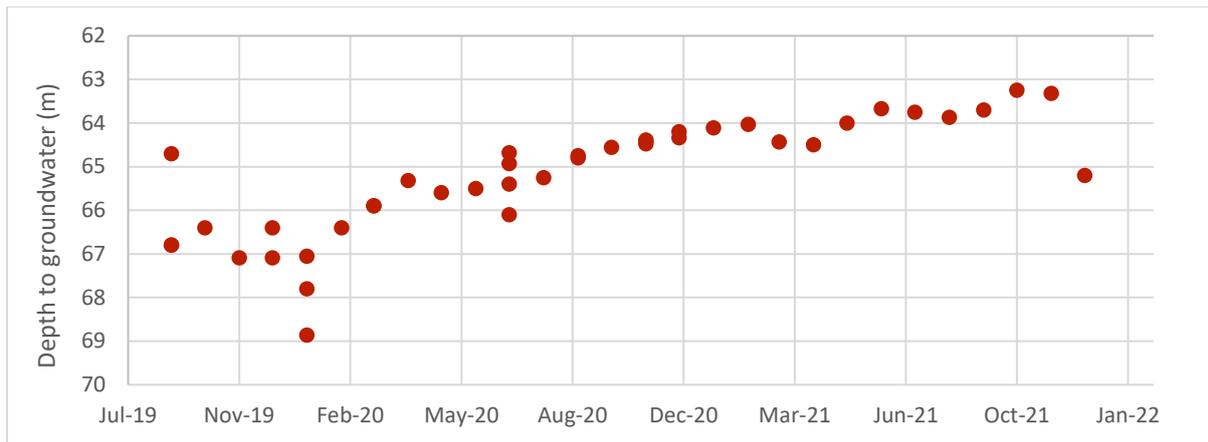
Figure 11: Standing water level BHAP6 (Production Bore).

Average standing water level at BHAP6 (the production bore) increased throughout 2021 in comparison to the previous reporting period (2019-20). Although remaining in use, the consumption of water from BHAP6 was decreased during this period, as shown in Section 6. There is a trend of increasing groundwater level in this aquifer, with monthly measurements presented in Figure 11. The reduced measurement in December 2021 has been attributed to the impacts of the water pump drawing down on the column of water within the bore, as it was in use moments prior to the measurement being taken.

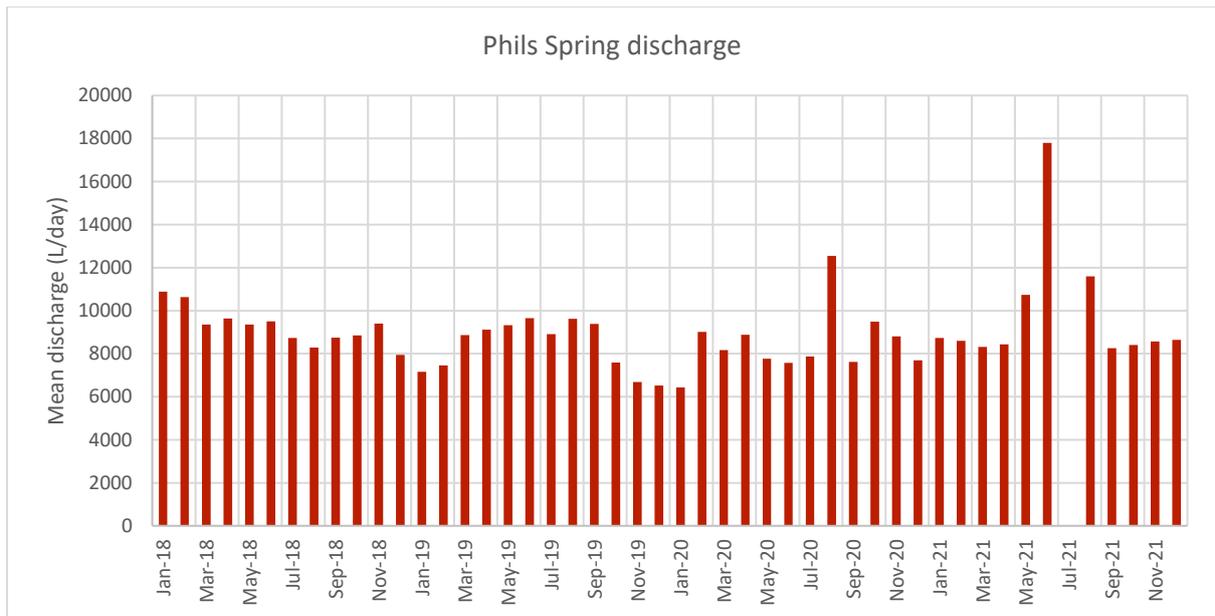
Figure 12: Mean discharge (L/day) observed at the Phils Spring monitoring location. Monitoring device was inactive between 4 June 2021 and 18 August 2021.

Phil's Spring is fitted with an electronic V-Notch weir monitoring device to continuously monitor flow rates. The average mean discharge (L/day) as calculated for each month is presented in Figure 12. Flow rate across the monitoring period was relatively steady, and comparable with previous reporting periods. The monitoring device experienced a technological issue between 4 June 2021 and 18 August 2021 and was unable to record data during this period. As such, June and August discharges were calculated on a reduced data set, and July was unable to be determined.

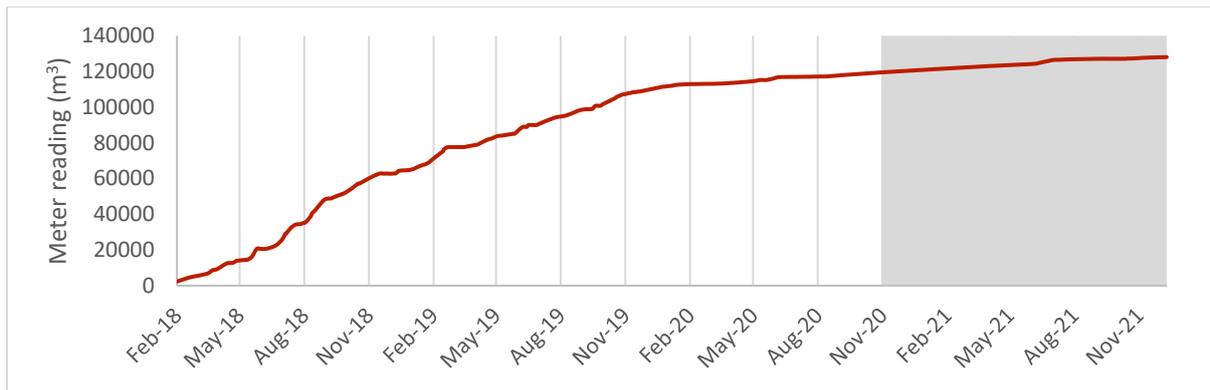
Figure 13: Meter readings (m<sup>3</sup>) for WAL 30111. The relevant period for this report is highlighted in grey.

Meter readings since February 2018 are presented in Figure 13, which clearly shows the trend of reduced water take in recent years.
