Ardmore Park Quarry

Annual Review

1 January 2024 - 31 December 2024

Site Name	Ardmore Park Quarry
Address	5152 Oallen Ford Road, Bungonia NSW, 2580
Project Approval	PA 07_0155 (Mod 3)
Environmental Licence	EPL 13213

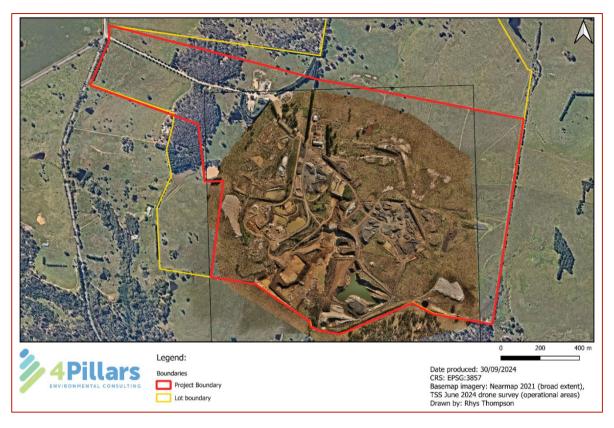
Figure 3: Operational footprint of the Project based on a June 2024 drone survey. Note, some minor georeferencing discrepancies between the drone images and underlying Nearmap basemap may be present. The Development Consent (i.e. Project Approval) boundary is represented in red ("Project Boundary"). The black square is associated with the extent of the drone image file and should be disregarded.

Ardmore Park Quarry (**the Quarry**) is a sand and hard rock quarry owned and operated by CEAL Ltd (**CEAL**), trading as Multiquip Quarries (**Multiquip**). The project is located 4 km south of Bungonia village and 25 km south east of Goulburn in the Southern Tablelands region of New South Wales. The Quarry falls within the Goulburn-Mulwaree Council (**GMC**) local government area. The regional and local context of the Quarry are presented in Figure 1 and Figure 2, respectively. The current operational disturbance footprint (as of June 2024, added in V2 of this Annual Review) in relation to the development consent boundary is presented in Figure 3.

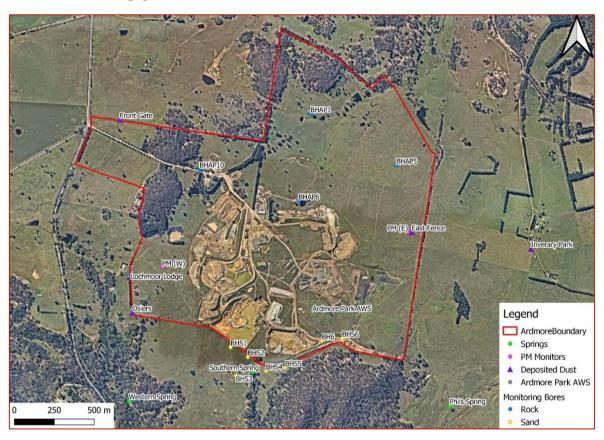
Figure 4: Monitoring locations.

The average monthly temperatures recorded by the on-site weather station (location shown in Figure 4, "PM10_W") ranged between 8°C to 20°C throughout the reporting period. The temperature range observed is heavily influenced by the Quarry's elevation within the Southern Tablelands Region. Average temperature is presented in Figure 5, along with site data from 2023, showing the relative consistency across the two years. 2024 data from the Goulburn weather station of the NSW Government's New South Wales Air Quality Monitoring Network¹ are also presented, and are consistent with the on-site data.

Particulate matter emissions are measured by two Sensirion SPS30 Particulate Matter Sensors installed with Atmos 22 and Atmos 41 weather stations, which have been established at two locations within the Quarry Site - PM (E) and PM (W), respectively - as shown on Figure 4. These sensors are real-time optical particle counters (OPCs), which obtain measurements based on the incoming particles scattering the incoming light, the extent of which is then detected by a photodiode and converted into real-time particle count and mass concentration values. This allows the sensors to record the levels of various particulate matter fractions simultaneously, including PM1.0 (0.3 to 1.0 µm), PM2.5 $(0.3 \text{ to } 2.5 \mu\text{m})$, PM4.0 $(0.3 \text{ to } 4.0 \mu\text{m})$, and PM10 $(0.3 \text{ to } 10.0 \mu\text{m})$, rather than requiring manual collection and analysis of filters for individual fractions. The weather stations where the particulate matter sensors are installed record a variety of parameters including temperature, wind and gust speed, rainfall, humidity, and wind direction. All of the data is automatically and continuously uploaded to an online portal, from which it can be observed or downloaded. The particulate matter data gathered can then be compared to the obtained weather data, to determine if and how the weather conditions influence the particulate matter readings obtained.

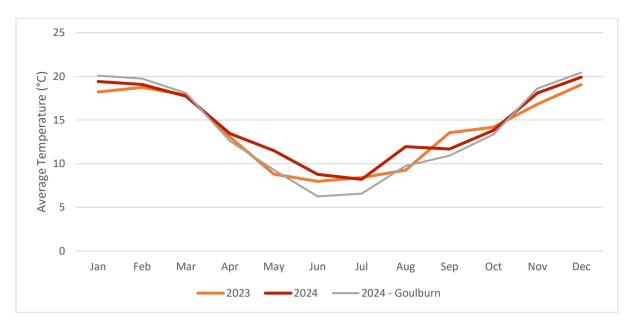
Figure 5: Average monthly temperature recorded at the site, 2024 and 2023, and the NSW Government's Goulburn weather station.

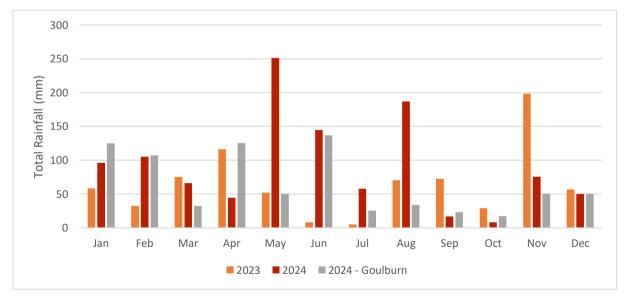
Figure 6: Total monthly rainfall recorded at on-site weather station, comparison of 2023 and 2024.

Data collected during 2024 indicated an increased level of rainfall in comparison to 2023, with approximately 1103 mm of rain recorded compared to 773 mm observed in the previous year (Figure 6). This was similar to 2021, when 1013 mm of rainfall was observed. It was noted that 2024 data from the Goulburn weather station was generally consistent with on-site data, however with some notable differences e.g. May, August. It was identified during the reporting period that there were some data fault and sensor errors with the on-site weather station that may have attributed to this. The supplier for the station was contacted for their advice and to make repairs where required. The weather station continued to operate during this time.

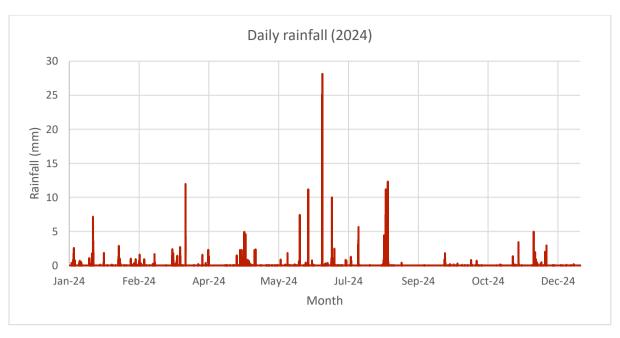
Figure 7: Daily rainfall recorded at on-site weather station.

Daily rainfall data from the on-site weather station has been presented in Figure 7, and - along with monthly data - can be used to assess trends in monitoring data.

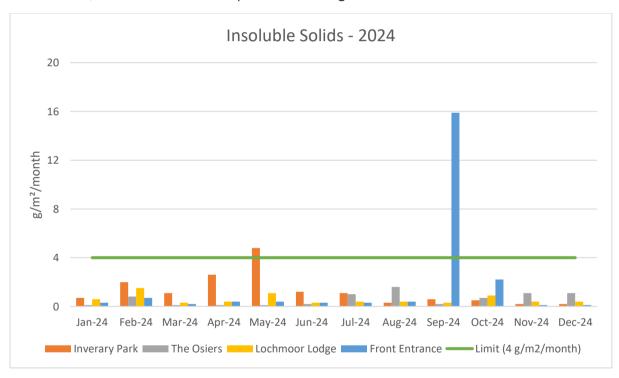
Figure 8: 2024 Deposited dust (insoluble solids) results. Limit of 4 g/ m^2 /month for total impact of particulate matter emissions generated by the project is presented as a green line.

Samples collected are analysed at a NATA-accredited laboratory, with the insoluble solids fraction of the total sample used to assess compliance with the air quality criteria specified in Condition 7 of Schedule 3 of the Mod 3 Approval (4 g/m²/month total, 2 g/m²/month incremental). Results for 2024 are presented in Figure 8.

As shown in the graph, there were a total of two instances where the primary results for insoluble solids were greater than the total limit, across two months (May, September).

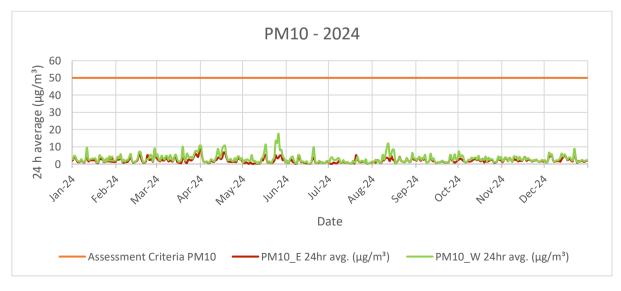
Figure 9: 2024 PM₁₀ data for both units, 24-hour averaging, with Project Approval limit.

The data for 2024 as a 24 hour average is presented in Figure 9 and Figure 10 for PM_{10} and $PM_{2.5}$, respectively, with the Project Approval limits included on the graphs. As shown, while particulate matter levels recorded by both units were slightly elevated at times, they were generally stable, and remained well below their respective limits throughout the year. It is noted that this data is for total particulate matter (including background levels), rather than directly attributable to quarrying operations.

The predictions in the 2008 EA for PM10 were that "with respect to the 24-hour average, the maximum PM10 concentrations is predicted to be less than the site-specific goal $50 \,\mu\text{g/m}^3$ at all assessment locations for the three scenarios considered". As presented in Figure 9, the maximum 24-hour average concentration of PM10 throughout the reporting period was 17.6 $\,\mu\text{g/m}^3$, in line with the predictions.

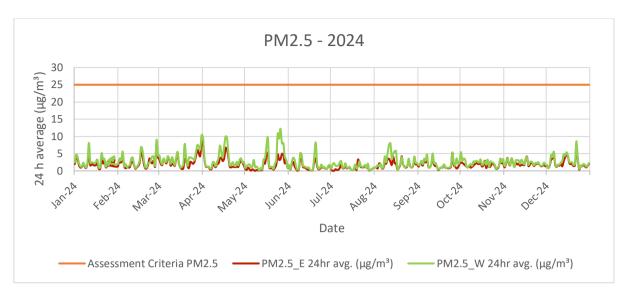
Figure 10: 2023 PM_{2.5} data for both units, 24-hour averaging, with Project Approval limit.

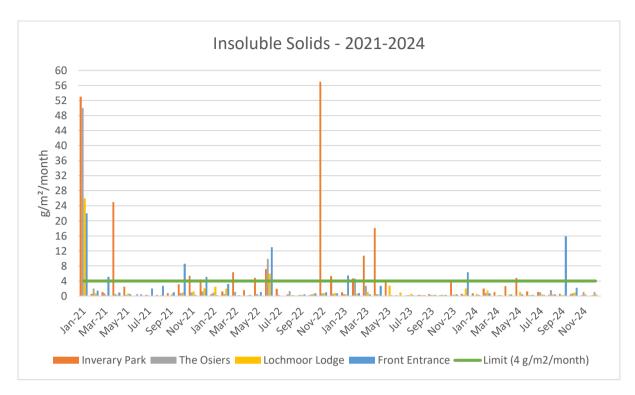
Figure 11: 2021-2024 deposited dust (insoluble solids) results. Limit of 4 g/m²/month for total impact of particulate matter emissions generated by the project is presented as a green line.

Results for deposited dust levels (as insoluble solids) for the reporting period compared to previous years are presented in Figure 11. Due to issues with graphing historical data, data earlier than 2021 has not been included. While some elevated readings were observed during the reporting period, values were generally similar to previous years.

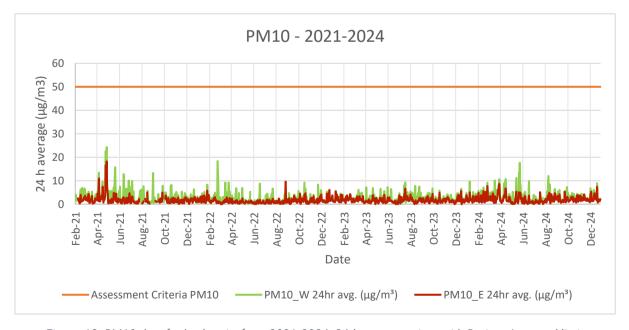
Figure 12: PM10 data for both units from 2021-2024, 24-hour averaging, with Project Approval limit.

Results for PM10 for the reporting period compared to previous years are presented in Figure 12. Across both units, levels were generally consistent with previous years, and lower than 2021.

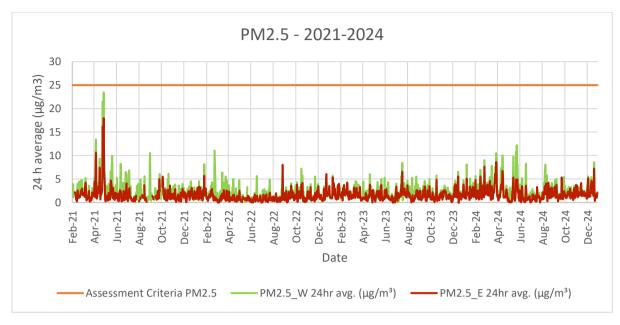
Figure 13: PM2.5 data for both units from 2021-2024, 24-hour averaging, with Project Approval limit.

Results for PM2.5 for the reporting period compared to previous years are presented in Figure 13. Across both units, levels were generally consistent with previous years, and lower than 2021.

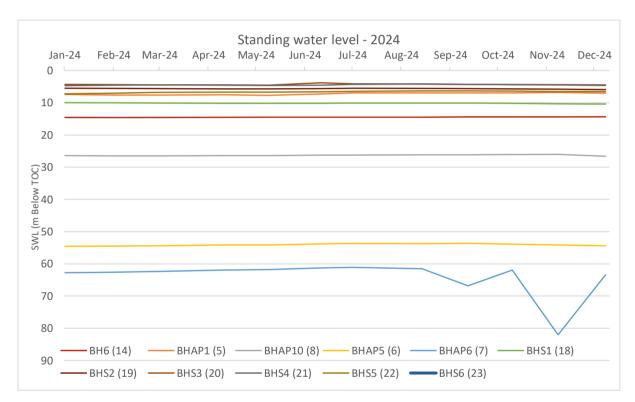
Figure 14: Monthly bore standing water level measurements during 2024. The reduction in SWL of BHAP6 during November is considered likely to be influenced by pumping of bore during/prior to measurement.

A summary of standing water level for all bores measured throughout the reporting period is presented below in Table 14, with monthly measurements presented in Figure 14.

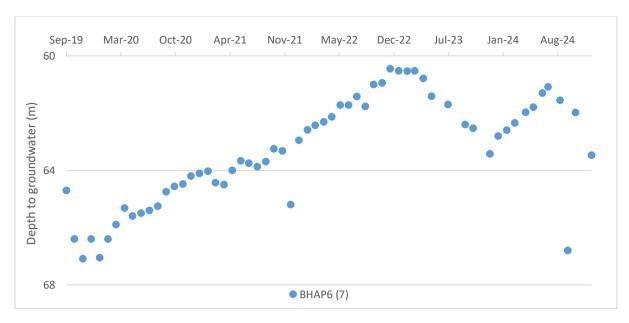
Figure 15: Standing water level BHAP6 (Production Bore). Note, measurements believed to be erroneous due to the influence of the pump (November 2024) have been removed from the graph.

The standing water level at BHAP6 (the production bore) fluctuated slightly throughout the reporting period, but the final measurement (63.47 m, December 2024) was only 0.67 m deeper than the first measurement (62.8 m, January 2024). The measured height at the end of the reporting period remained higher than the measurements taken during the 2019 reporting period (e.g. 67.09 m, November 2019). Monthly measurements are presented in Figure 15.

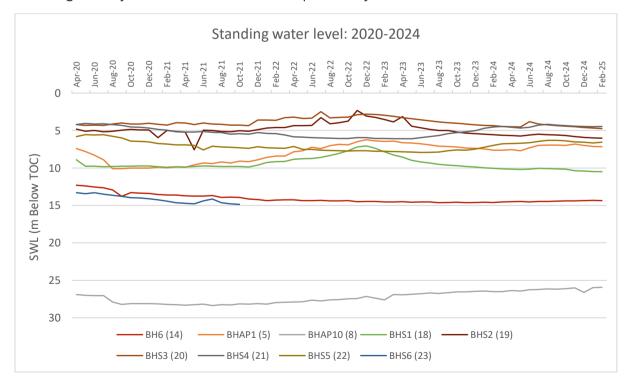
Figure 16: Standing water level since 2020. Note BHAP6 is not shown as it is presented in Figure 15, and BHAP5 is not shown due to the change in SWL observed following the relining of the bore (refer to 2023 Annual Review).

Condition 5b(iii) of Schedule 5 of the Project Approval requires that a comparison of monitoring results to the "monitoring results of previous years" is included in the Annual Review. A comparison of standing water level (SWL) readings obtained during the reporting period to previous years (since 2020) is provided in Figure 16, below, and in Figure 15 for BHAP6. Although fluctuations across bores can be observed, the levels remain generally consistent with data from previous years.

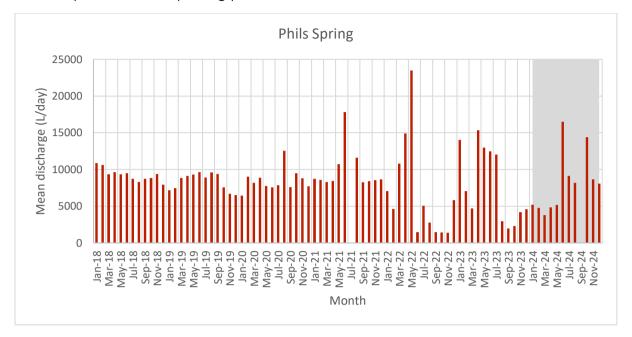
Figure 17: Mean discharge (L/day) observed at the Phils Spring monitoring location. Device inactive between 4 June 2021 and 18 August 2021. Manual measurements are presented for October-December 2024. No measurement was obtained in September 2024. The relevant period for this report is highlighted in grey.

The average mean discharge (L/day) as calculated for each month is presented in Figure 17. Flow rate across the monitoring period fluctuated, however the trend was relatively

consistent with the previous reporting period. Flow rates observed were slightly higher than the previous two reporting periods (Table 21).

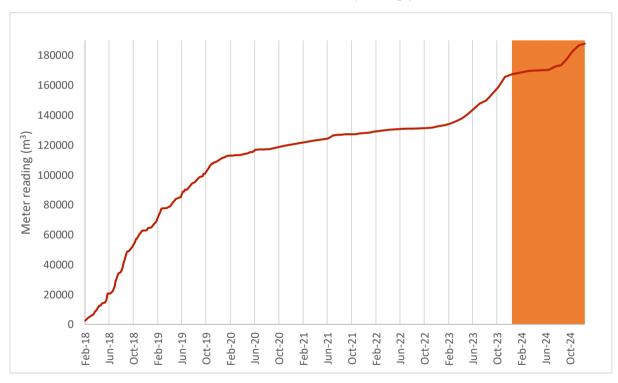
Figure 18: Meter readings (m^3) for WAL 30111. The relevant period for this report is highlighted in orange.

Meter readings for BHAP6 since February 2018 are presented in Figure 18, which shows the increase of water take towards the end of this reporting period.
